CAPTAIN S. R. HELLER, JR., USN, IVO FIORITI, and JOHN VASTA

AN EVALUATION OF HY-80 STEEL AS A STRUCTURAL MATERIAL FOR SUBMARINES

PART II

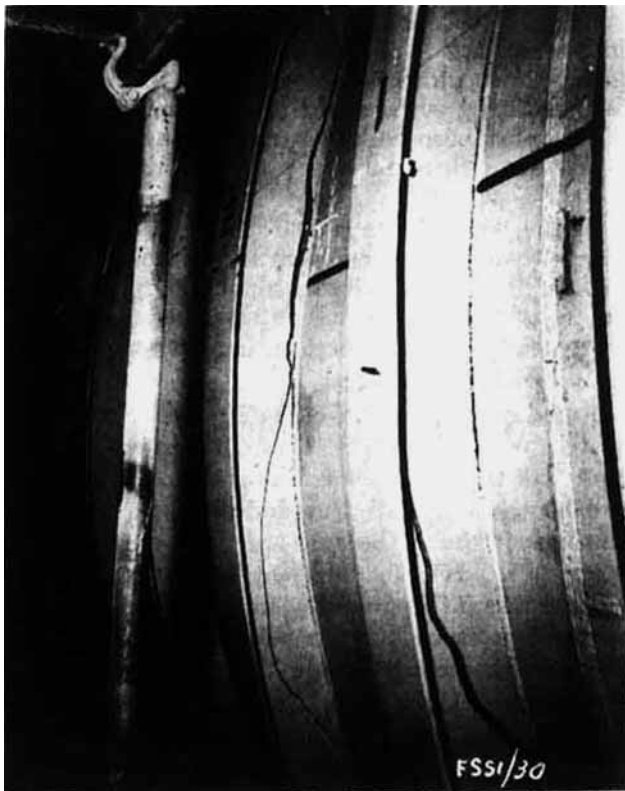
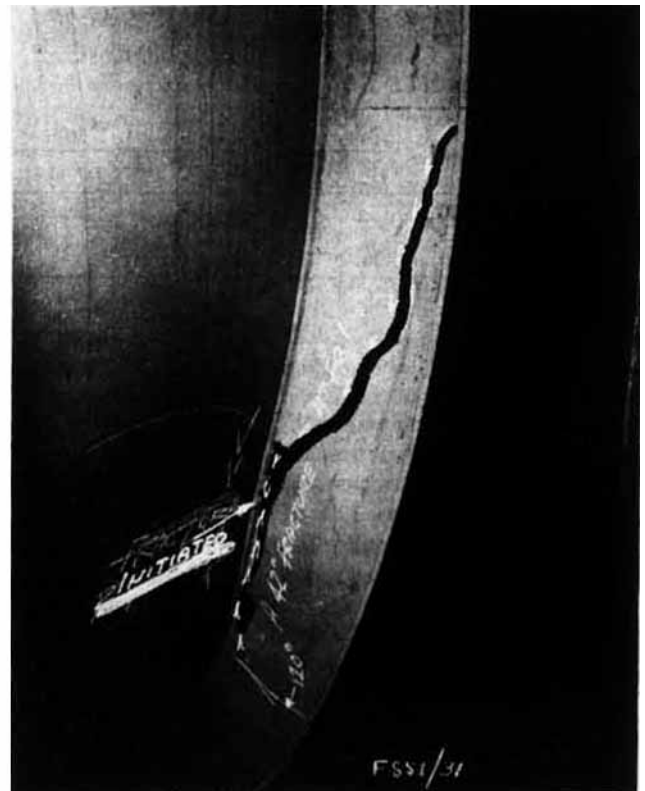
A—Overall View

B—Close-up View

Figure 12. Underwater Explosion Test Results of HTS Structural Model.

In comparison to the performance of the HY-80 models, that of the HTS model (Model 1) was poor. The first shot against Model 1, although of the same severity as for Model 2 (same strength) but of less severity than for Model 3 (same weight), caused several brittle fractures of considerable extent in the framing system; see Figure 12. Model 1 can, for all practical purposes, be considered to have failed on the first shot. Clearly it would be expected to withstand neither another explosive shot nor any appreciable hydrostatic load.
